Department of System Safety and Risk Protection
Final Report
Derailment Of Train #308, Westbound Yard Lead Track
Alexandria, Virginia
~~May 2, 2003~~ 4/17/03

Department of System Safety and Risk Protection
Final Report
DERAILMENT
ALEXANDRIA YARD LEAD
DECEMBER 9, 2003

Department of System Safety and Risk Protection
Investigation Committee Summary Report
Derailment, Red Line, Silver Spring, Pocket Track
August 19, 2004

DEPARTMENT OF SYSTEM SAFETY and RISK PROTECTION
Interim Investigation Report
Derailment of Six Car Consist at West Falls Church Yard on 10/01/04

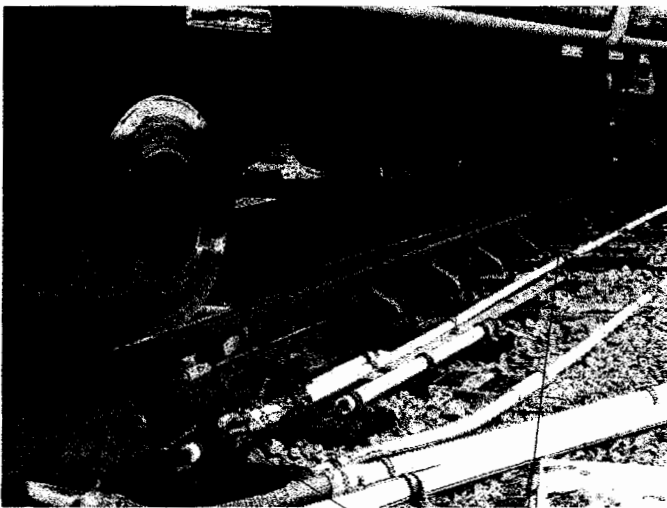
Note: last truck of lead car 5056 located on the stock rail and first truck of 5057 on the open switch point.

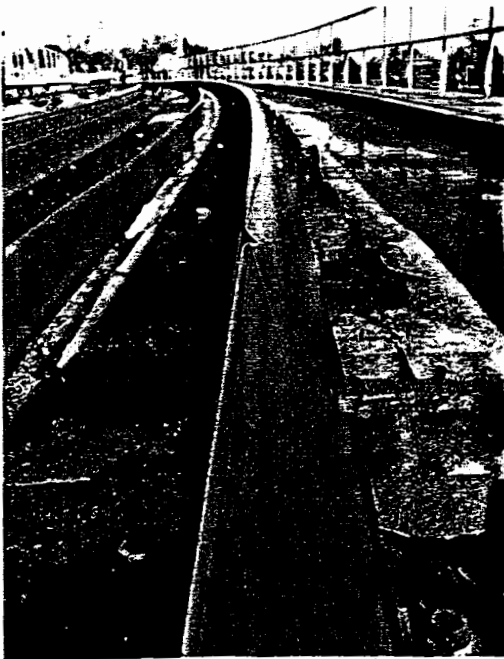
Photo shows wheel marks on top of rail at point of derail.

High coefficient of friction caused by colder than normal temperatures and unlubricated rail on a 320' radius unrestrained rail. The investigation is continuing, looking at track and vehicle conditions.

Lubricate track in this area, and install guardrail.

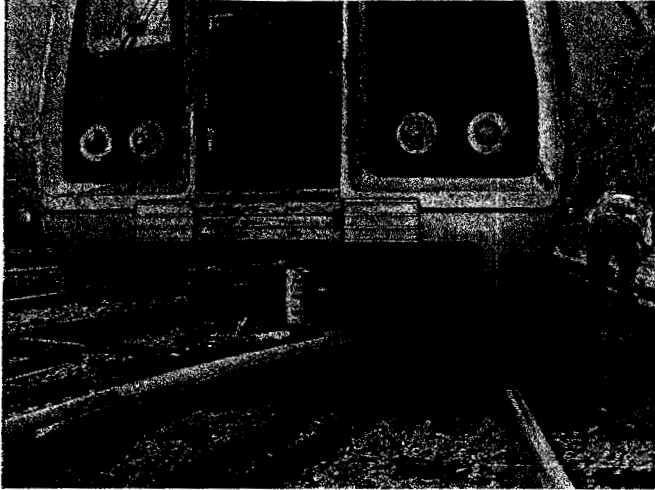
Car 5186, front trucks derailed in the pocket track, Silver Spring, MD, 08/19/04.

- dry, unlubricated rail
- side wear on the switch point
- the conformal contact of the wheel on the rail
- reduction in acceleration at the point of derailment

- ▶ Lubricate all switches similar to the switch at which the derailment occurred. This is an interim measure, until this type of switch can be provided with a guard rail, which would prevent similar derailments. There is an ongoing program to install guards on switches similar to the type involved in the derailment.
- ▶ Review the WMATA Track Standards for acceptable allowable switch point side-wear.
- ▶ Conduct a wheel/rail interface study against current WMATA track and car standards.
- ▶ Closely monitor track inspection cycles and reports from inspection personnel for trends and anomalies. Implement corrective action.
- ▶ Establish a policy to conduct a full wheel/rail interface study for each new series of rail cars that WMATA procures.

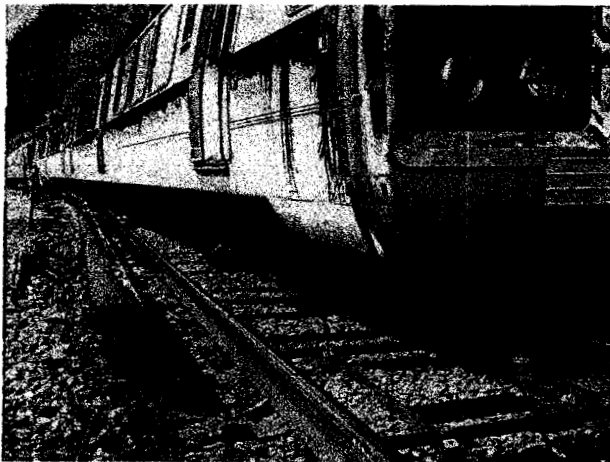
View of front derailed trucks of Car 5186.

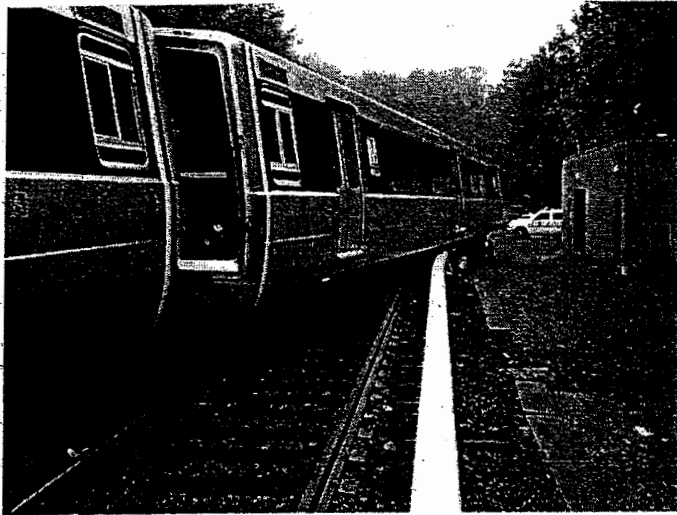
Front view of car 5139.

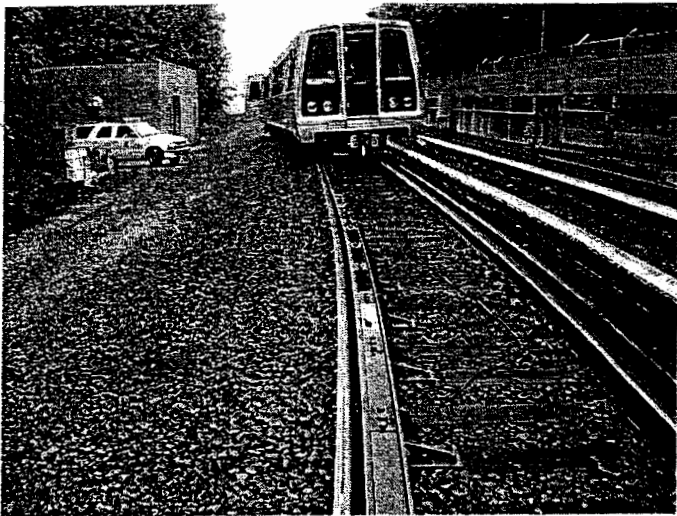
Rear view of car 5138.

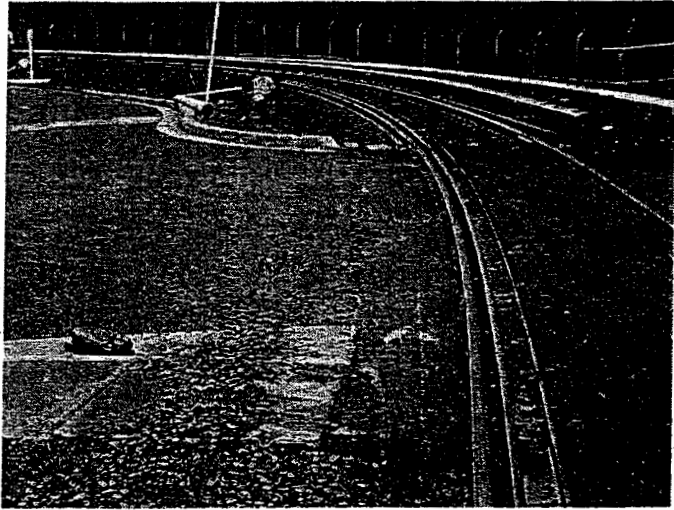
View of curb damage and flange grooves across the road crossing.

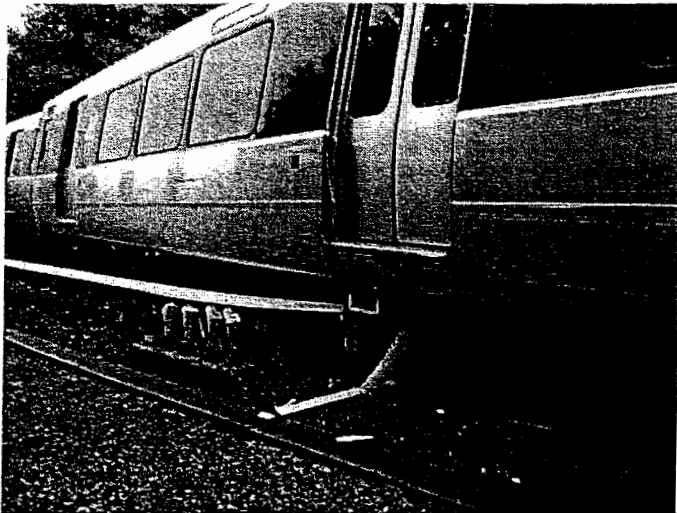
View of damage to the side of car 5139.
